**EAST DIKE
ARLINGTON MILL RESERVOIR
NH 00027**

**PHASE I INSPECTION REPORT
NATIONAL DAM INSPECTION PROGRAM**

AUGUST 1978

Name of Dam East Dike, Arlington Mill Reservoir
State Located New Hampshire
County Located Rockingham
City or Town Salem
Stream Spicket River
Date of Inspection 6/7/78 and 6/28/78

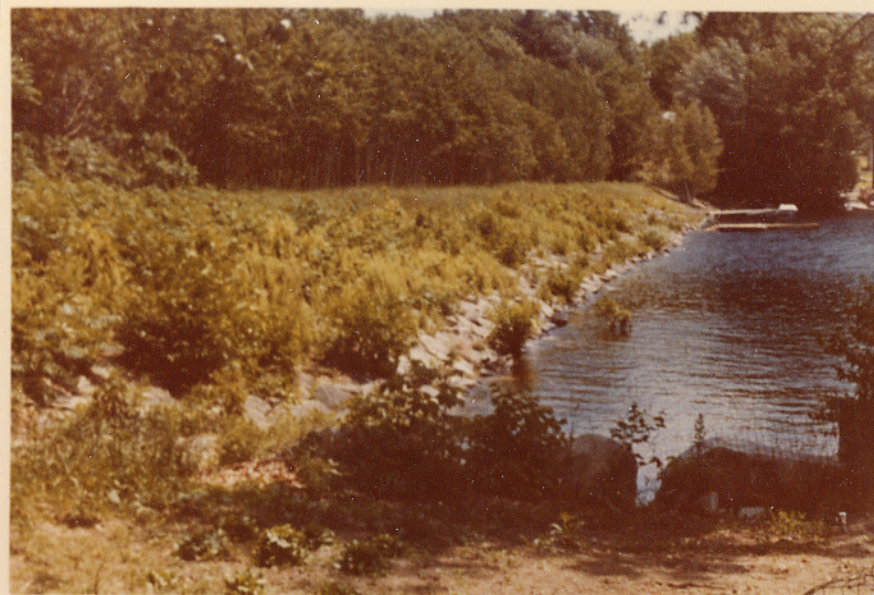
The upstream slope is covered with riprap in generally good condition. There are a small clump of birch trees and a few 4- to 5-inch diameter stumps on the upstream slope near the southeast abutment, but the upstream slope is otherwise clear of brush and trees.

<u>Photo No.</u>	<u>Description</u>
1	Upstream face of dam looking southeast from northwest abutment.
2	Photo taken from southeast abutment, showing two docks (one partially hidden behind trees), a clump of birch trees on the upstream face of dike near southeast abutment, crest of dike with footpath along crest, cable and damaged gate across crest, and tree-covered downstream slope with evidence of recent clearing of downstream slope near abutment (in foreground).
3	Several tree stumps, about 4 to 5 inches in diameter (one to right of metal clipboard), near crest of upstream slope close to southeast abutment, as viewed from edge of reservoir.
4	Upstream slope of dike looking toward northwest abutment, showing riprap. Brush has been cleared from upstream slope.
5	Plastic water pipe near northwest abutment, which is laid above ground up to the top of the riprap on the upstream face and below ground across the crest to a camp north of the northwest abutment.

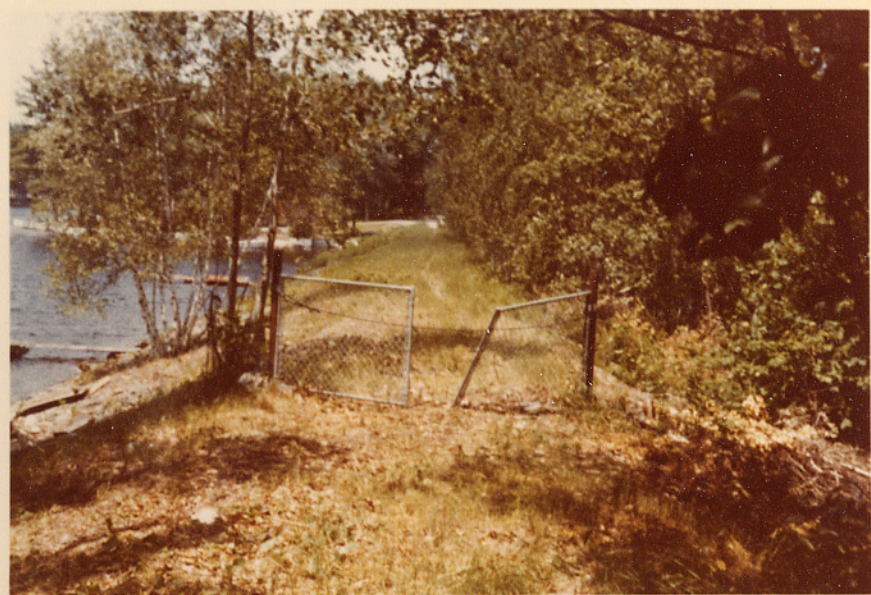
2

Two docks have been built adjacent to the upstream slope of the dike. At the southeast abutment, the contact with the upstream face is only sparsely vegetated and appears to have been used for boat launching.

- a. Retain a competent engineer to investigate the apparent seepage.
- b. Cut all trees on the upstream and downstream faces and retain a competent engineer to supervise the removal of trees, roots and replacement with proper backfill.
- c. Order the removal of the water pipe mentioned in the report and retain a competent engineer to specify a proper backfill after removal of the pipe.
- d. Order the removal of the docks.

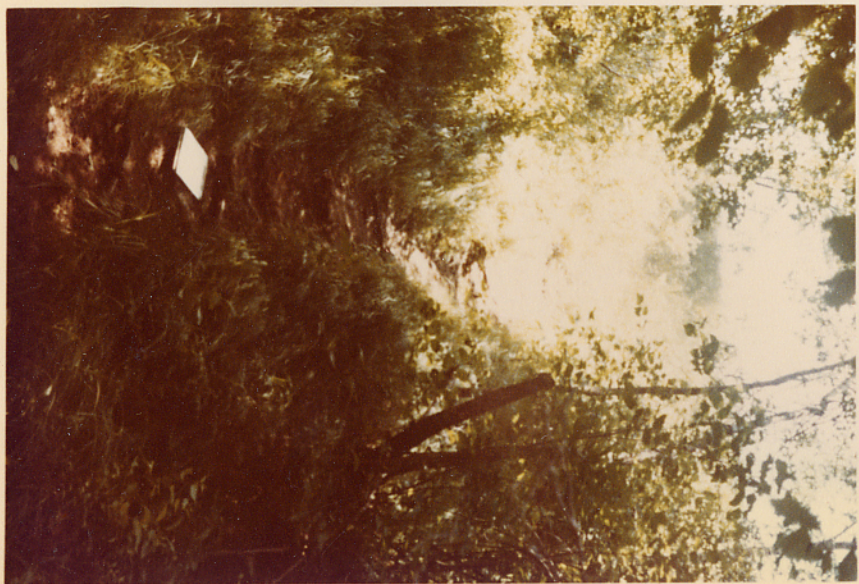
Trespassing has led to the development of a bare path along the crest of the dam, another bare path from the crest to the toe of the downstream slope, and a sparsely vegetated area at the contact between the upstream slope and the southeast abutment. There is also an extensive growth of brushes and trees on the downstream slope, and evidence (in the form of moisture-loving vegetation) that seepage may be discharging on the downstream slope about 3 feet below the reservoir level at the time of the inspection. These conditions could lead to future problems if not remedied.

| 7 | Looking up the downstream slope from a point at the toe of slope showing a foot-path (motorcycle path?) that runs up the slope. Metal clipboard is lying on the path. |

- (1) The dike should henceforth be kept clear of all trees and shrubs. A dense growth of grass should be maintained.
- (2) A more conscientious method of preventing trespass should be adopted.
- (3) It is recommended that the owner adopt a program of regular observation visits by a responsible individual. Visits should be at least weekly and a permanent log kept.

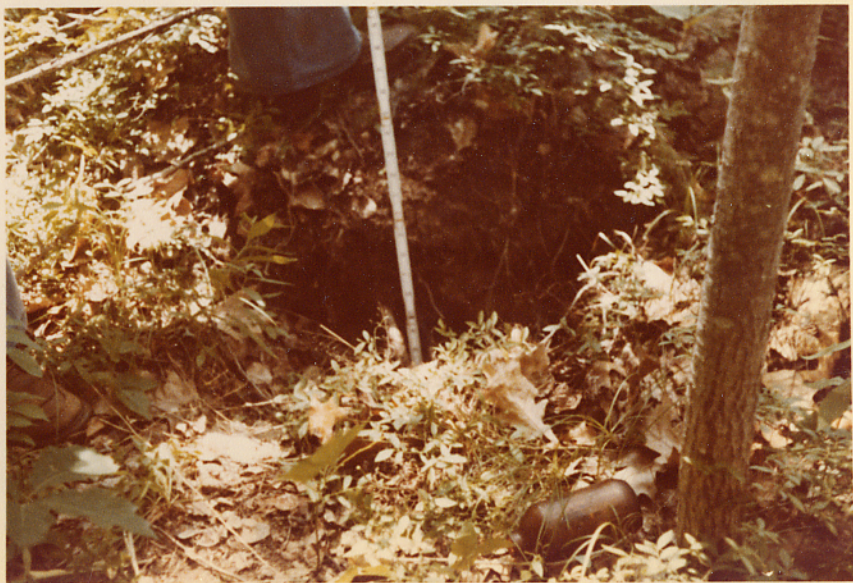
One filled-in hole which appears to have been an animal burrow, was seen on the downstream face.

| 8 | Filled-in hole, which appears to have been an animal burrow, on the downstream face of the dike. |
